# Manhole Inspection Summary

Manhole # S35AA2013MH

Insp Date: **2/28/07 1:50 PM**

**Location** Address: **329 TAPLOW RD**

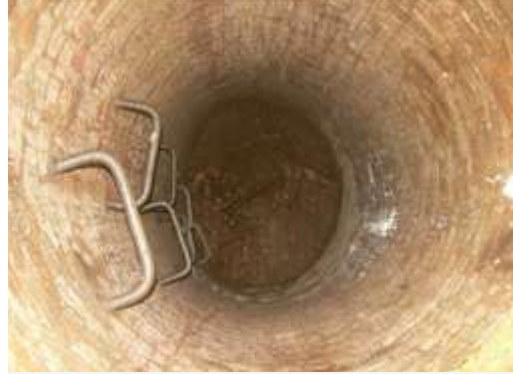
Top View

**Channel** Material: **Brick** ☐ Parged ☒ **Debris** (not Condition related)

Channel debris.

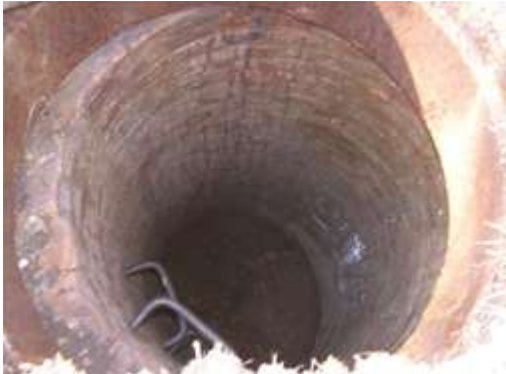
Defect

**Frame** Offset: **2** (in.) Condition: ☐ Sound ☐ Cracked ☒ **Leaks**

Infiltration: ☐ None ☒ **Joint** ☐ Cracks ☐ Mortar ☐ Roots ☐ Wall

Frame offset. Adjustment deterioration and infiltration. Barrel infiltration.

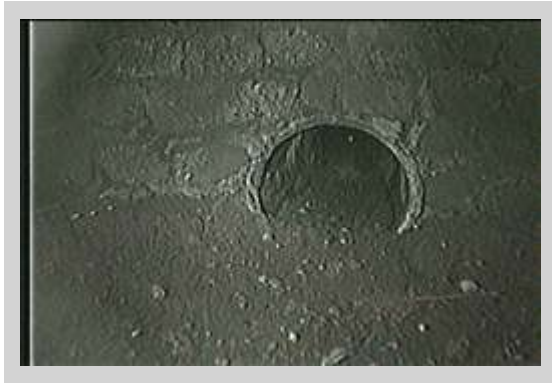
8 in. Circular Gravity Sewer  
Pipe Out @ 12 O'Clock

Deposits: ☐ None ☒ **Mud** ☐ Sludge ☒ **Debris** ☐ Grease

Silt Depth: **0.5** (in.) Deposits Extent: **Light**
